INTERNAL FIRE ENDURANCE TEST L3 IN ACCORDANCE WITH IMO RESOLUTION A.753 (18) FOR DISCONTINUOUS FILAMENT WOUND FIBERGLASS PIPE ND350

Manufacturer: TECNOPLAST SRL

July 2016

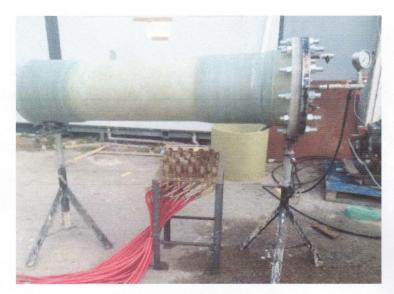
Picture no. 1: Specimen and test device

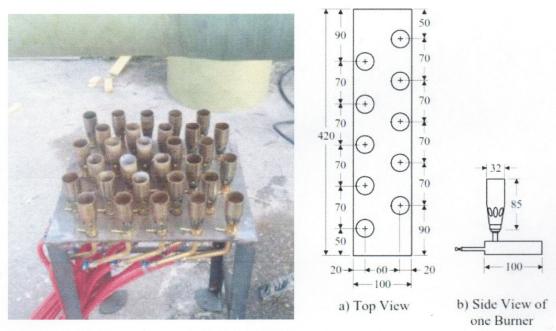
Picture No. 2: Burner assembly

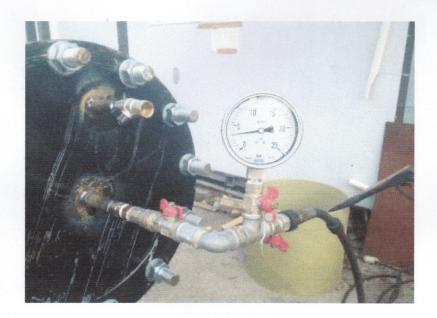
Picture No. 3: Pressure at start of the test

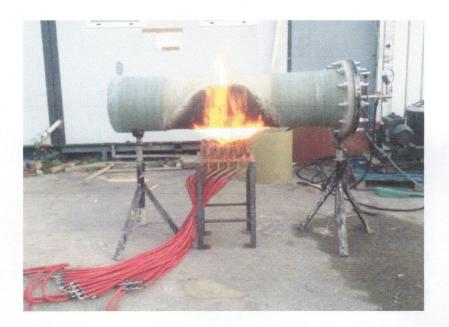
Picture No. 4: Fire endurance test. Test time 5 min.

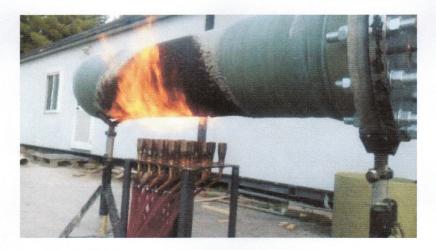
Picture No. 5: Fire endurance test. Test time 10 min.

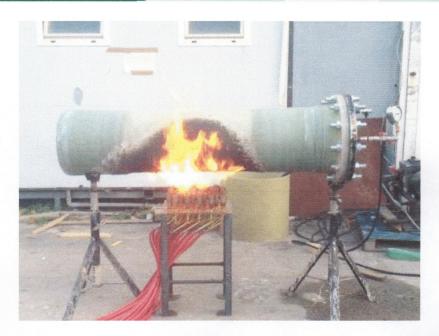
Picture no. 6: Fire endurance test. Test time 18 min.

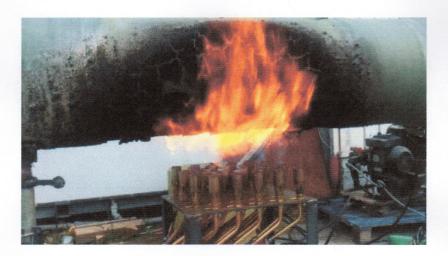
Picture no. 7: Fire endurance test. Detail (Test time 18 min.)

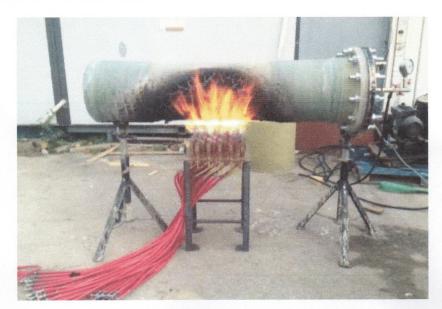
Picture no. 8: Fire endurance test. Test time 25 min.

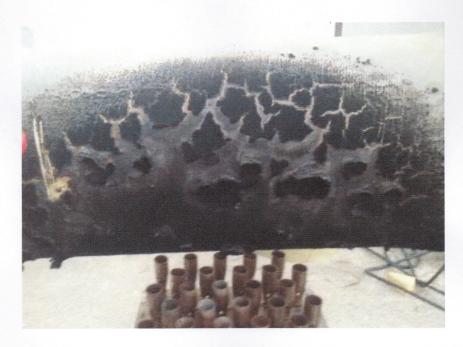
Picture no. 9: The test specimen after the fire endurance test. The exposed face of the pipe

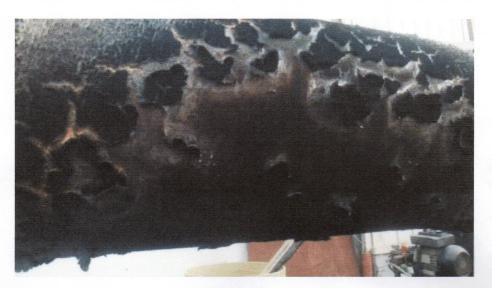
Picture no. 10: The test specimen after the fire endurance test. The exposed face of the pipe

It was also observed that there was not damages or erosion of the mechanical wall of the pipe but only the external coating was damaged as appear from picture no. 10 above.

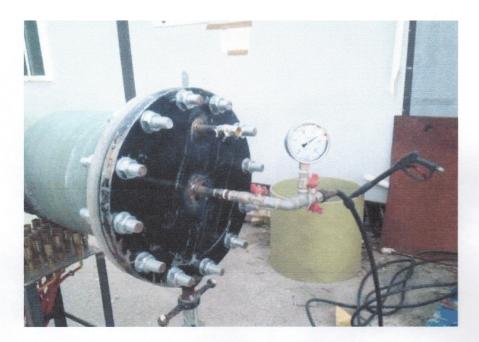
Picture no. 11: start of pressure test at 18 barg

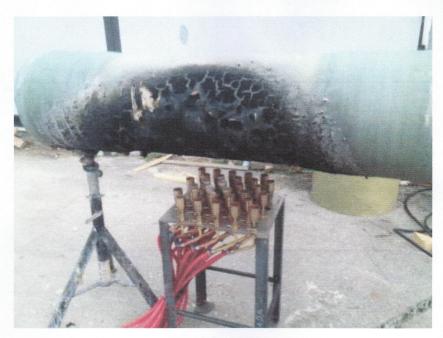
Picture no. 12: Test Specimen during pressure test (no leakage observed)

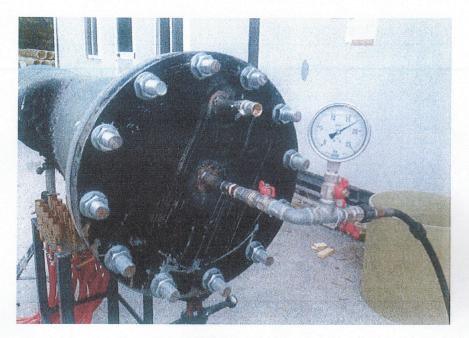
Picture no. 13: Test Completed after 15 min (no leakage observed)
